Cable Bay/ New Zealand

Project description

The Cable Bay Stormwater Line consisted of 96m of DN800 SQ1 34-10 pipe and was to be drilled and pulled through a steep section of land in preparation for a new coastal subdivision (*Picture 1 and 2*).

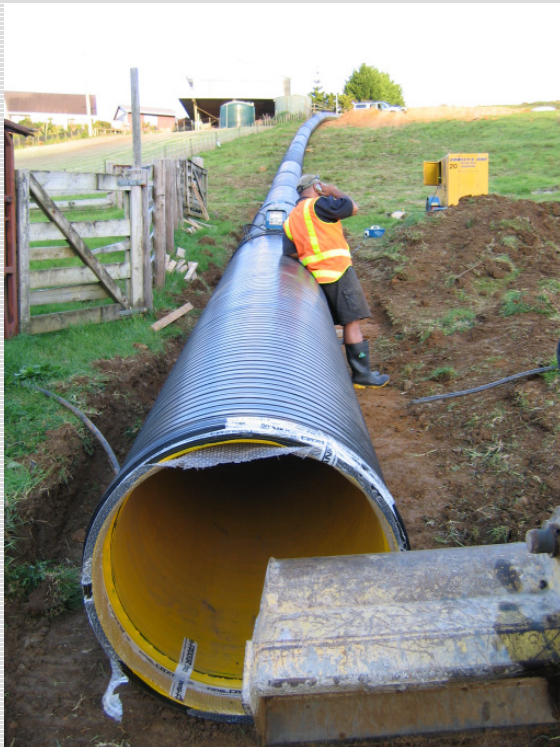
Picture 1: DN 800 SQ1 34-10 section of spiral pipe SQ-Profile/New Zealand

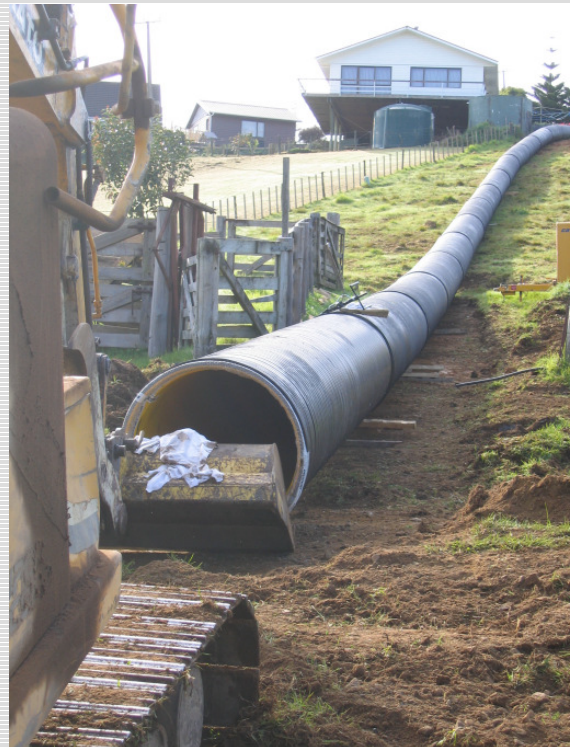
Picture 2: Preparation for installation

However due to the driller failing to achieve grade the job was open cut and the pipe dragged through the steep cutting without the need for sheet piling.

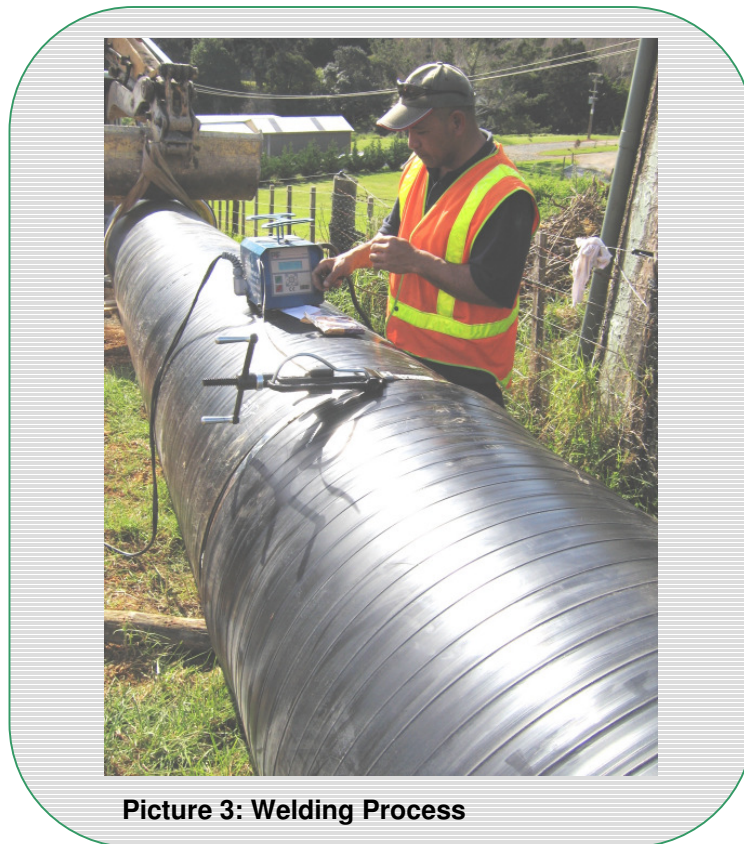
Picture 3: Welding Process

The welding (*Picture 3*) was done by Solo Plastics Ltd and the contractor Donovan Drainage did the pipe installation.
